NDI No. PA 00212
PENN DER No. 26-31

STAR JUNCTION No.2 DAM
WILLIAM McCORMICK

PHASE I INSPECTION REPORT
NATIONAL DAM INSPECTION PROGRAM

ACKENHEIL & ASSOCIATES ~~GEO SYSTEMS, INC.~~
CONSULTING ENGINEERS
1000 BANKSVILLE ROAD
PITTSBURGH, PENNSYLVANIA 15216

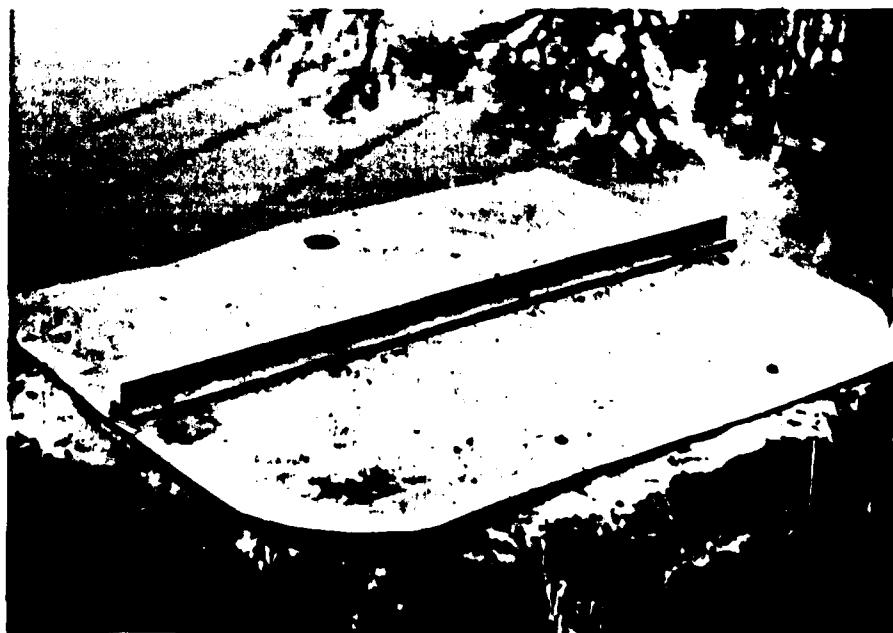
e. Outlet Works: The only visible evidence of an outlet works facility was a steel plate covered masonry structure at the toe of the embankment. The structure was partially inundated by the lower lake. A (valve) stem and associated bracing, all badly bent, were observed inside the structure; operation was not possible.

b. Outlet Works: Visual observations were insufficient to determine the condition or even the existence of the outlet works facility. No mechanism or device for upstream flow control was observed.

PHOTO 10. CLOSE-UP OF OUTLET WORKS CONTROL BOX
